## Town Hall Burgkunstadt

Vogtei 5  
96224  
Burgkunstadt, Germany

## RENOVATION PROCESS

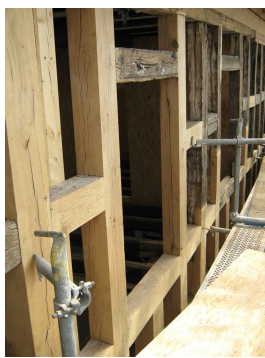
In the course of the renovation, the previous infill was completely removed. Afterwards, the timber-work was repaired. The new infill was lined with special lightweight clay bricks from Claytec. In addition, internal lightweight clay insulation boards were installed to improve the insulation performance. Today, the wall temperature control is achieved by means of a wall heating system embedded in clay plaster. The wood carvings were repaired in a manner appropriate to the monument by filling them with a special wood crack paste from the Caparol company. Then all wooden elements were painted with a linseed oil paint.

During the refurbishment in 1970, a colour scheme in brown tones had been chosen. However, since the non-diffusion-open paint had caused some damage, it was completely removed in the course of the current renovation. In close cooperation with the monument conservation authorities and after an extensive research and investigations on the building, it was possible to determine the original colour shade applied by Jörg Hoffmann

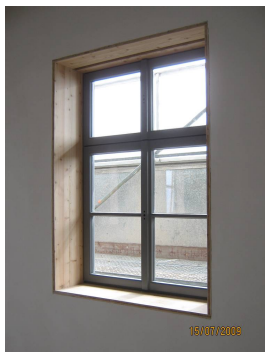
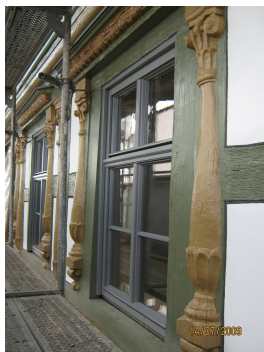
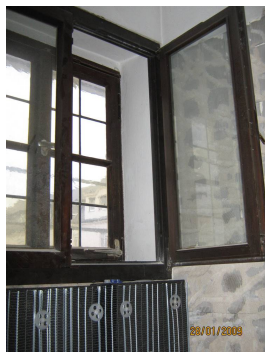
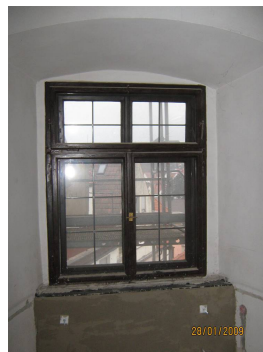
The existing box-type windows were completely replaced in the renovation process. In

addition, they were equipped with sun protection.

From an energy point of view, insulating glazing was to be installed, although this did not comply with the guidelines of the heritage office. For this reason, a classic drawn glass from the Schott company was used for the exterior panes of the insulating glass windows. This is characterised by its uneven surface, which is created by using the Fourcault method in the manufacturing process. So the original appearance of the façade could be retained.

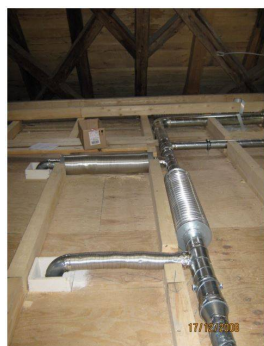
As a result of the renovation, the town hall received a ventilation system that supplies the administrative rooms on the 2nd floor.

| Original roof build-up | New ventilation system |
